**FRETTING OF AISI 9310 AND SELECTED FRETTING
RESISTANT SURFACE TREATMENTS**

by R. C. Bill
Lewis Research Center
Cleveland, Ohio 44135

TECHNICAL PAPER to be presented at the Annual Meeting of the
American Society of Lubrication Engineers
Montreal, Canada, May 3-5, 1977

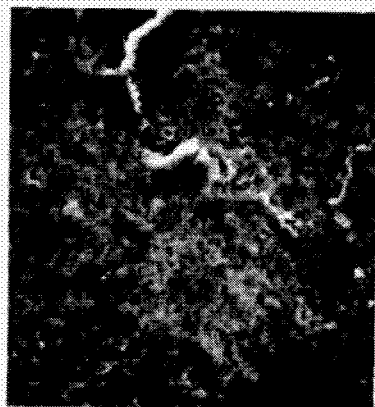
(a) 7.5 - 10 μm AMPLITUDE (0.3 - 0.4 MILS).

(b) 35 μm AMPLITUDE (1.4 MILS).

(c) 62 μm AMPLITUDE (2.5 MILS).

Figure 3. - Fretting damage features resulting from 10^6 fretting cycles in dry air, under the indicated fretting amplitude conditions. X1000.

causing surface damage are still qualitatively similar to those predominating at lower amplitudes. Figure 3 summarizes the types of surface damage observed as the fretting amplitude was increased from 7.5 micrometers up to 62 micrometers. The surfaces examined showed signs of crack initiation and "exfoliation." Thus, for applications in which one of the mating components is subject to significant fatigue loading, variations in slip amplitude alone (at least above 7.5 micrometers) would not be expected to have an important effect on observed fretting fatigue life. Fretting fatigue results generally show that fatigue life is in fact negligibly affected by slip amplitude beyond the 5 to 10 micrometer range (ref. 6).

mechanisms, in particular corrosion and three body abrasion. The micrographs in figures 3 and 5 show significant surface cracking and spallation up to at least 10^6 cycles, indicative of fatigue, with a finer scale process, possibly corrosion combined with 3 body abrasion (no striations or scratches can be seen) after 12×10^6 cycles.

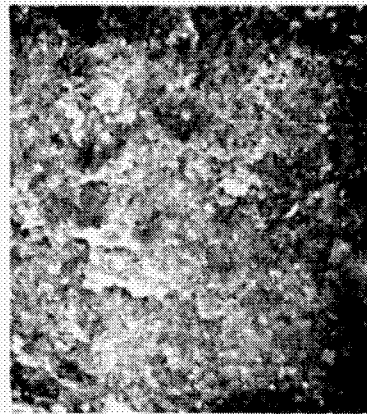
(a) 10^4 CYCLES.

(b) 3×10^4 CYCLES.

(c) 10^5 CYCLES.

(d) 12×10^6 CYCLES.

Figure 5. - Typical fretting damage features seen after the indicated fretting exposures under the following fretting conditions: 35 μ m amplitude, 163 Hz frequency, 1.47 N load, dry air. X1000.

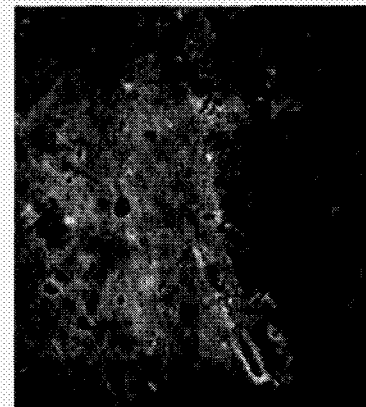
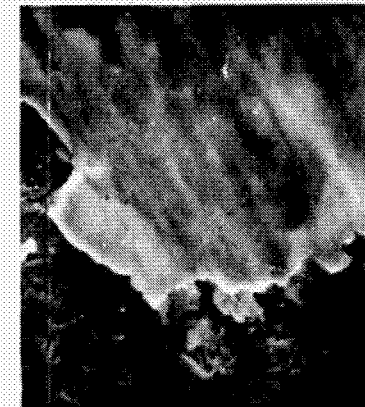
(a) 10^5 CYCLES, X100.

(b) 10^6 CYCLES, X100.

(c) FRETTING DAMAGE AT RANDOM LOCATION IN CONTACT AREA, X1000.

(d) BUILD-UP OF TRANSFERRED MATERIAL, EDGE OF CONTACT AREA, X1000.

Figure 6. - Build-up of transferred material resulting from fretting in moisture saturated air under a 1.47 N normal load at 163 Hz, 35 μ m (1.4 mil) amplitude.

Fretting experiments conducted in moisture saturated air produced results distinctly different from those seen in dry air. First, the wear volume is increased by a factor of from 5 to 8 after 10^6 fretting cycles. Second, adherent buildups of material, apparently oxidized debris, are observed in and around the contact areas as may be seen in figure 6. It is apparent that the presence of moisture significantly alters the rheological properties of the debris causing it to become "sticky" and cohesive, forming the observed layered deposits. Waterhouse (ref. 10) addresses the influence of moisture on the oxidation of iron based debris, with debris generated in the presence of moisture being softer than that generated in dry air. It is felt that the accelerated wear observed for the case of AISI 9310 steel when fretted in saturated air is primarily the result of more rapid corrosion. Experiments conducted in air at a controlled 40 percent relative humidity showed a fretting wear volume of 20 to $25 \times 10^{-5} \text{ mm}^3$, slightly higher than that measured for dry air.

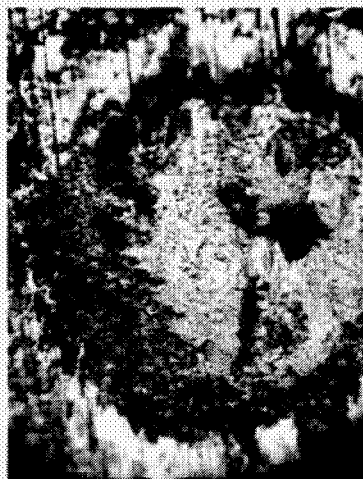
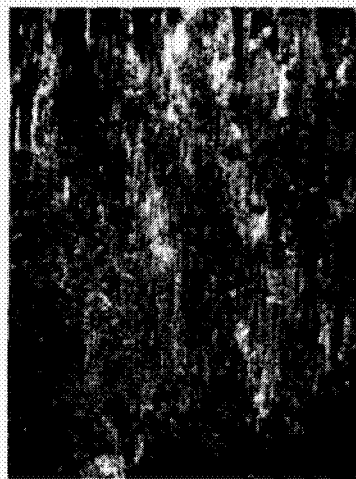
Figure 8. - Surface damage to AISI 9310 resulting from fretting against carburized 9310. After fretting in dry air (left), the 9310 showed heavy wear in the center of the contact area, with distinct pitting damage around the edges. Close examination reveals a mosaic of interconnecting cracks over the entire contact area after fretting in saturated air (right). X327.

No wear was measured on the carburized 9310 surface after fretting against untreated 9310 steel. However, extensive transfer to the carburized surface took place with the final contact situation being one of 9310 steel against 9310 steel. Wear to the untreated surface was indistinguishable from baseline wear under dry air conditions. Figure 8 shows the presence of considerable oxidized debris embedded in the fretting surface, with the presence of fine surface cracks indicating incipient spallation. Striations also visible on the surface suggest that abrasion by embedded debris particles was also contributory. Under saturated air conditions, wear to the untreated surface was 3 to 4 times the baseline. Again, very heavy metallic transfer to the carburized surface occurred. It is proposed that under fretting conditions the hard carburized material could more readily displace the protective surface oxides in the presence of moisture, and promote more extensive adhesion between the surfaces than took place under dry air conditions. The untreated material, being the weaker of the two, would then be expected to transfer to the carburized surface.

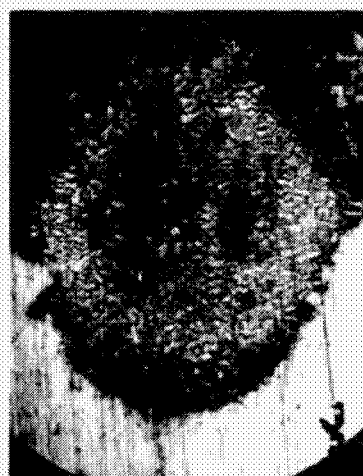
Figure 9. - Fretted surfaces on untreated AISI 9310 and Cr plated 9310 after 10^6 cycles in moisture saturated air under a 1.47 N normal load, 163 Hz fretting frequency and 35 micrometer amplitude. X127.

Low wear to the hard chromium plate was observed after fretting in dry air, and some transfer of 9310 steel to the chromium plated surface took place. Wear to the uncoated surface was slightly higher than the dry air baseline. When fretting was conducted in saturated air however, the chromium plate was observed to wear, and wear to the uncoated surface was reduced. The fretted chromium plate showed a nearly featureless surface, while on the mating 9310, "islands" of transferred chromium could be seen (fig. 9). It is hypothesized that the transferred chromium was in an oxidized form, and being embedded in the uncoated 9310 steel surface, promoted a 2-body abrasive action to the chromium plate.

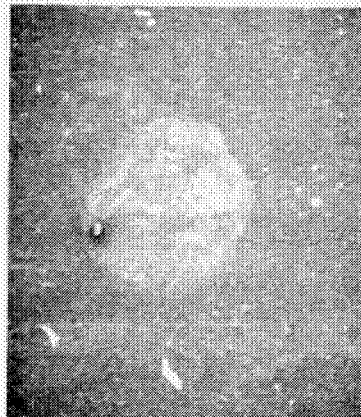
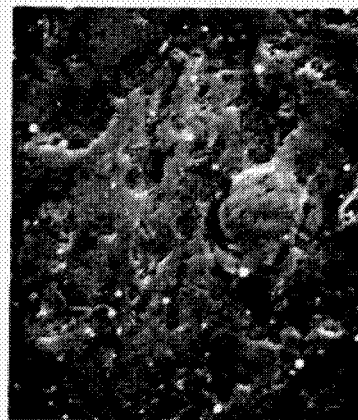
Figure 10. - Fretting damage to the surface of uncoated AISI 9310 after 10^6 cycles against Ag coated 9310 in dry air. The material on the surface is identified as being silver.

Under dry air fretting conditions, Ag plate performed as a sacrificial coating, itself undergoing wear while the opposing uncoated surface showed considerably reduced fretting damage compared to the baseline. SEM and x-ray dispersion analysis indicated that a thin, non-uniform deposit of Ag was present on the uncoated 9310 steel surface after fretting in dry air as may be seen in figure 10. Fretting under a moisture saturated air environment did not result in a significant difference in the performance of the Ag plate; it still worked as a sacrificial coating, but more wear to the uncoated 9310 steel surface was seen than under dry air conditions. Considerably greater experimental scatter occurred.
